Dam Site 1

Overall View of Dam

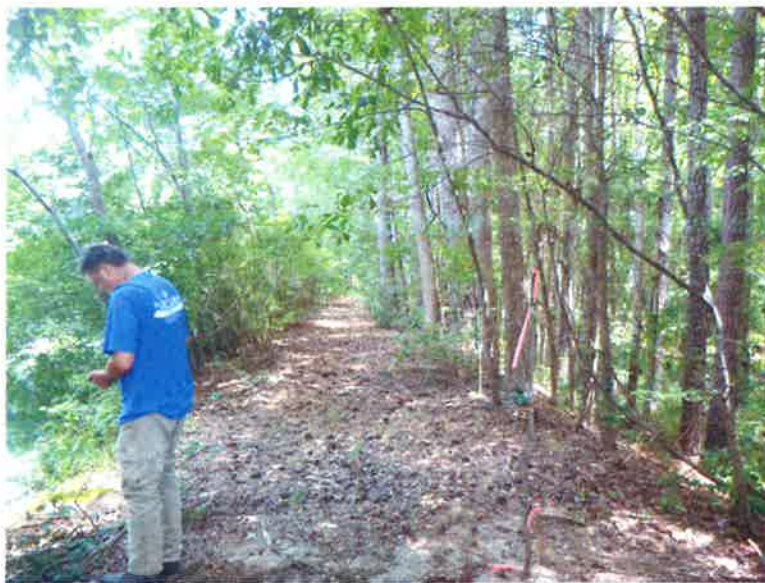
This dam is in a state of significant disrepair. It is believed at one time this dam included a stand pipe and piped spillway. At the inspection, neither outlet work could be found. Just downstream of the dam is another wet pond. At the inspection, it looked that this downstream pond is fed in part by seepage coming out from underneath the dam for Dam Site 1. Currently, the dam is served by two overland spillways: one located in the eastern abutment, and one located in the

western abutment. Based on the inspection of the dam, it would appear the dam in the vicinity of the eastern overland spillway is overtopping.

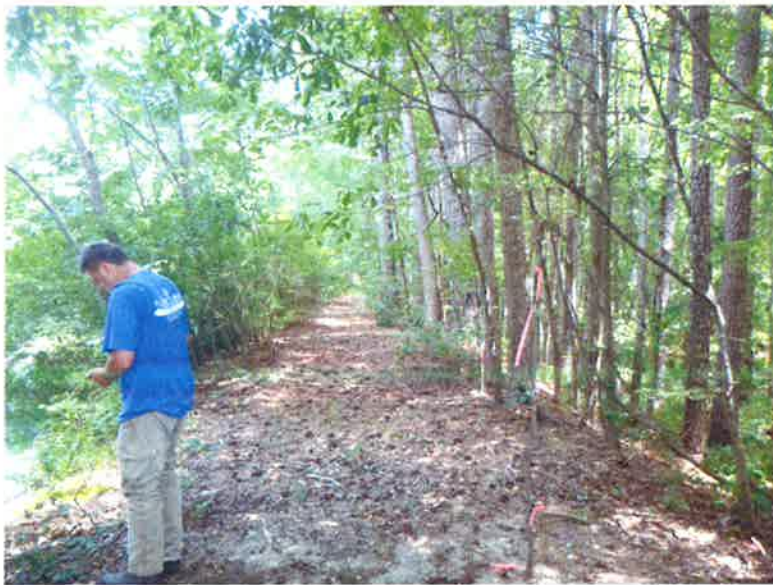
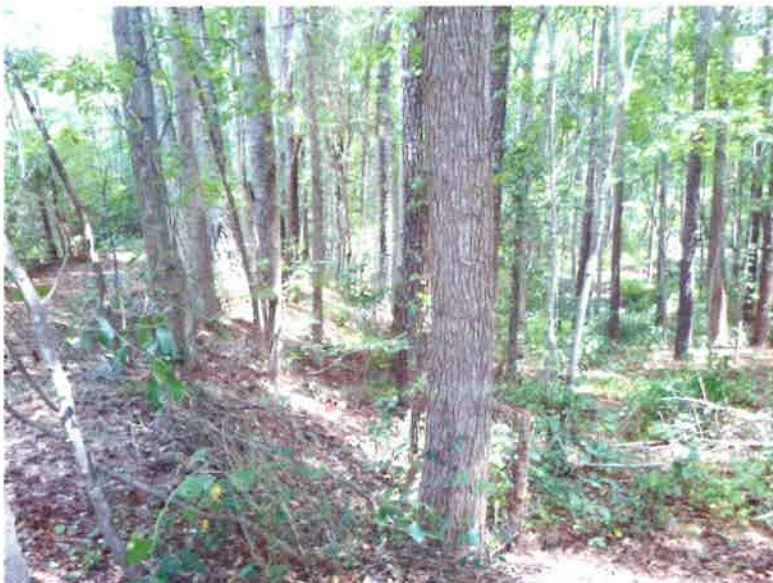
The top, upstream face, and downstream face of the dam are significantly overgrown. **Routine maintenance Item: Remove all trees (six inches in diameter or less) and all overgrowth.**

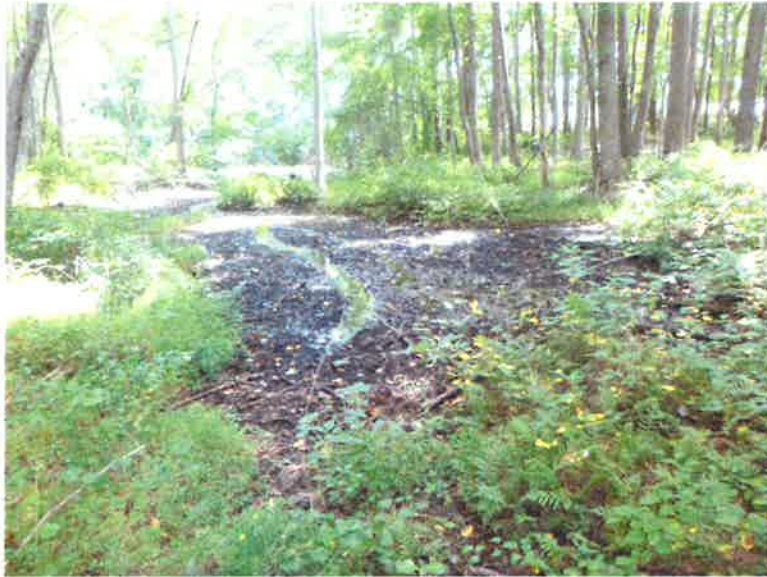
Just downstream of the downstream toe of the dam, a stream exists. It is believed this flow is principally the result of seepage from under the dam. **Routine Maintenance Item: Monitor (at the toe) the seepage for changes in the quantity of water, changes to the wetland vegetation at the toe, and the emergence of soil boils or active coffee-stained water. It is recommended also that the normal pool be monitored for significant (and/or rapid) drops in water surface.**

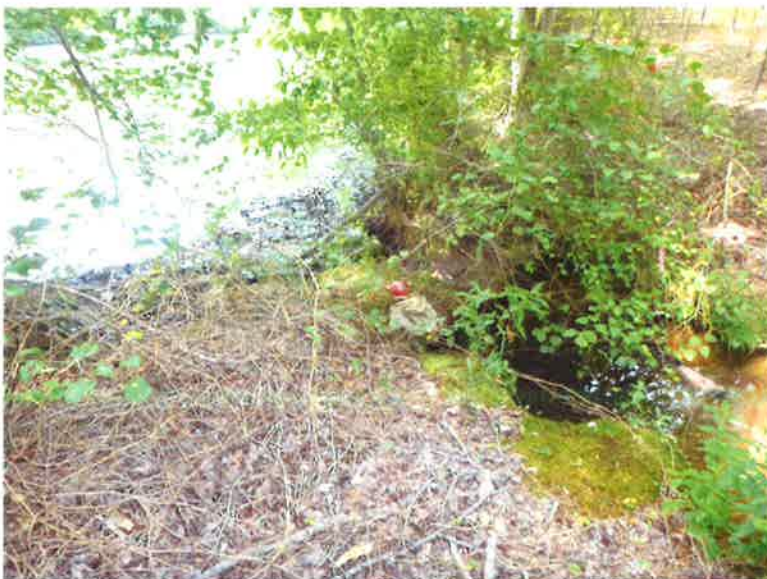
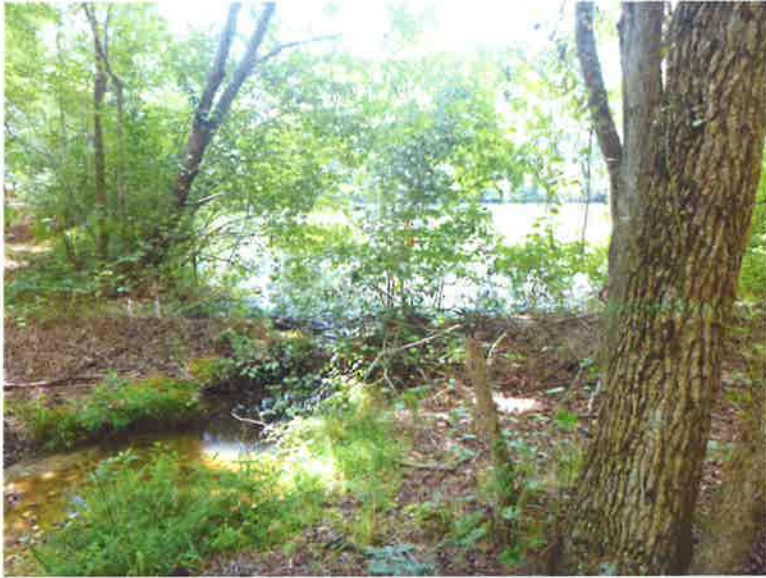
The dam in the vicinity of the eastern abutment, where the “pseudo overland spillway” is located, appears to be overtopping. **Routine Maintenance Item: Clear-out the spillway of excess vegetation and sediment build-up, and monitor the overtopping condition for significant erosion, tree uprooting, etc.**
