Dam Site 2

Vitals

Elemental Inspection of Dam for General Maintenance Only

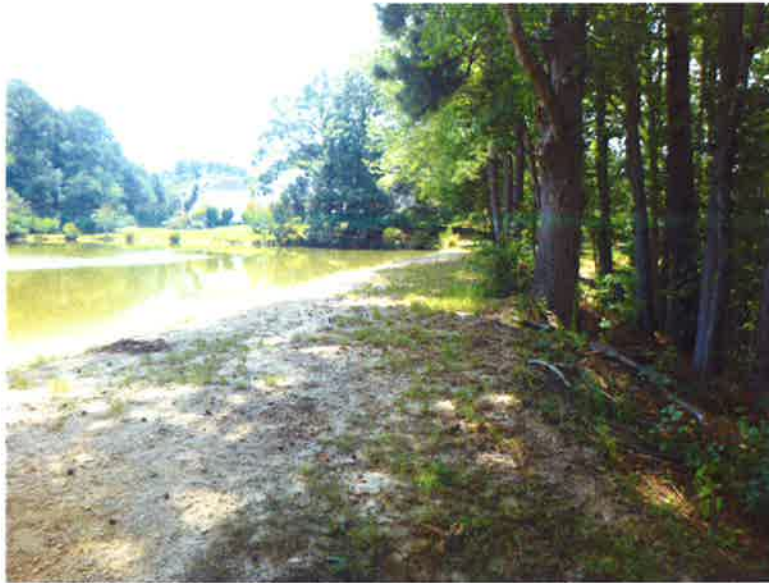
Overall View of Dam

This dam is in a state of significant disrepair. At one time, this dam included a functional stand pipe and piped spillway. At the inspection, both outlet works appeared to have been completely compromised. Approximately 20-ft downstream of the toe, a wet, mushy area (with wetland vegetation) was noted. This wet zone is, most likely, the result of seepage through the dam. Currently, the dam is served by one overland spillway that includes a riprap exit channel that crosses through the back yard of one home.

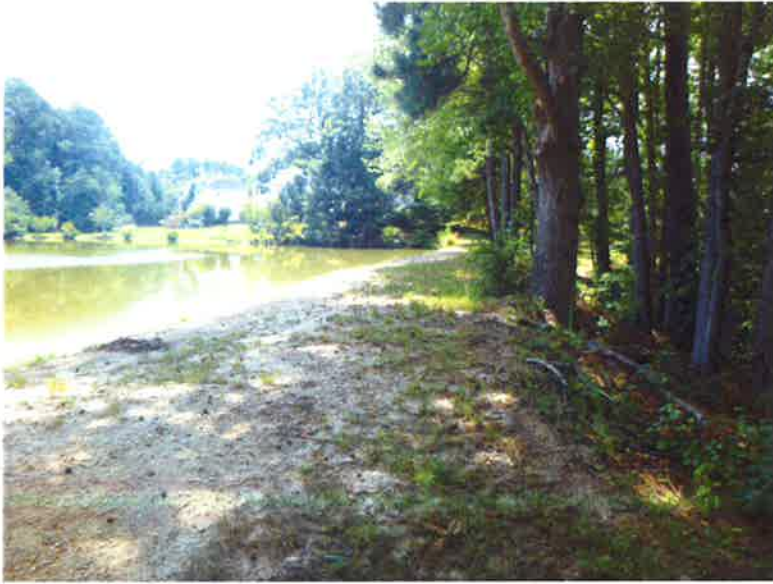
The upstream face and top of the dam are largely bare of vegetation. **Routine Maintenance Item: Establish grass on these surfaces.**

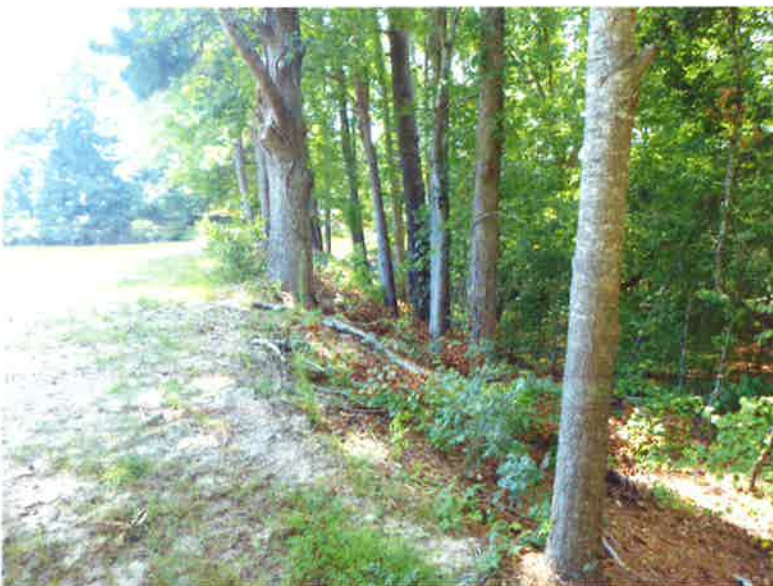
The downstream face of the dam is significantly overgrown. **Routine Maintenance Item: Remove all trees (six inches in diameter or less) and all overgrowth.**

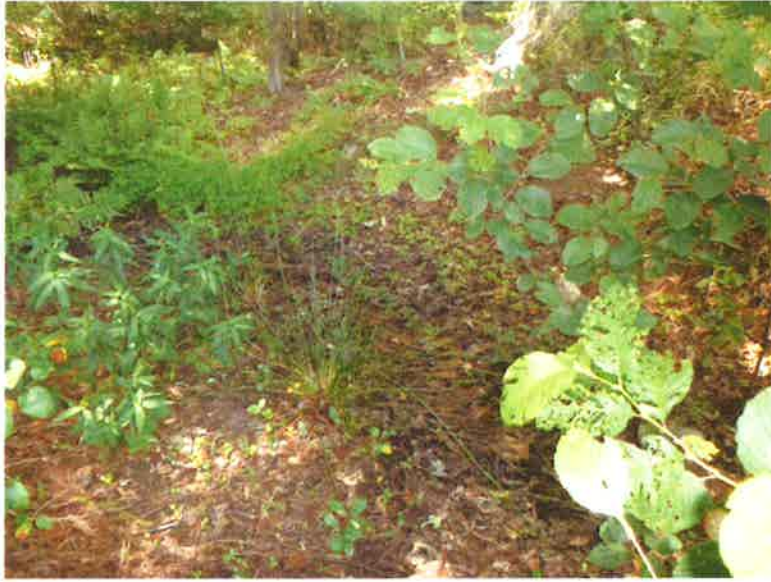
Just downstream of the downstream toe of the dam, a wet zone exists. It is believed this zone is principally the result of seepage from under the dam. **Routine Maintenance Item: Monitor (at the toe) the seepage for changes in the quantity of water, for changes to the wetland vegetation, and for the emergence of soil boils or active coffee-stained water at the toe. It is recommended also that the normal pool be monitored for significant (and/or rapid) drops in water surface.**

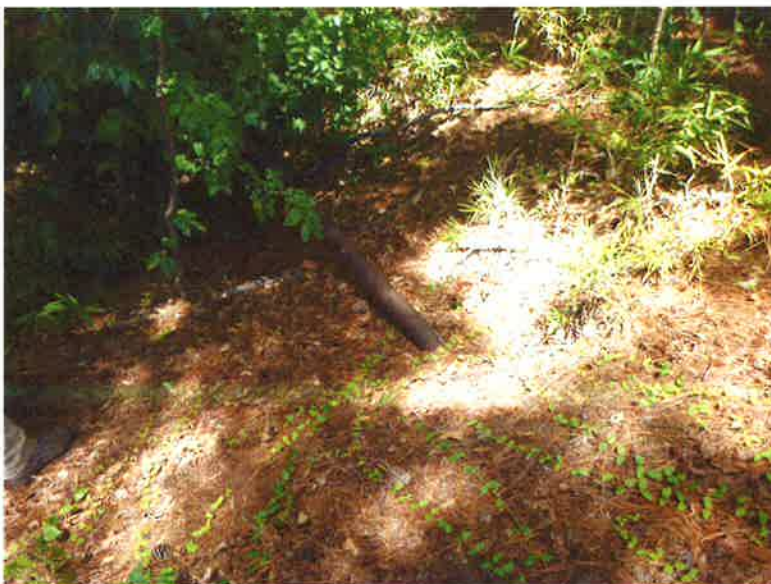
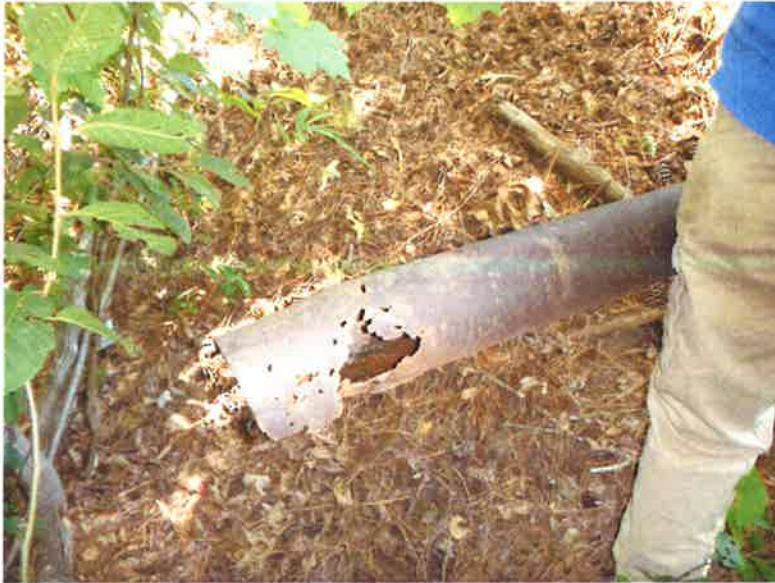
Failed Outlet Works

As indicated above, the outlet works have failed. **Routine Maintenance Item: Monitor these for changes in flow or condition.**

- Eliminate the failed outlet works (e.g., stand pipe and spillway pipe).
- Remove all woody vegetation from the dam.
- Install a new concrete riser and spillway system.
- Install an overland emergency spillway.

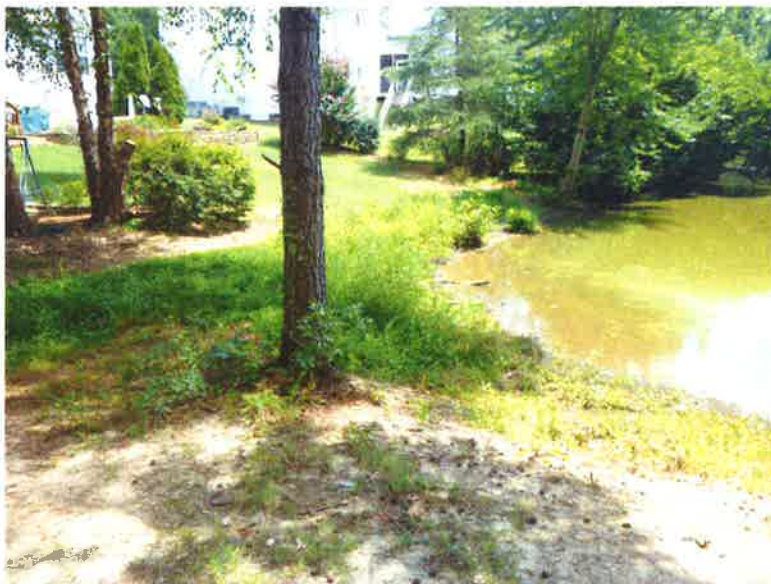
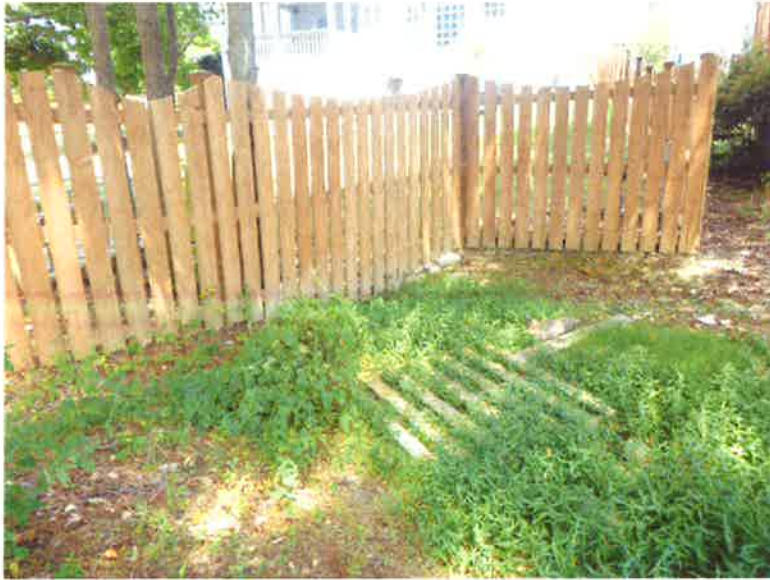
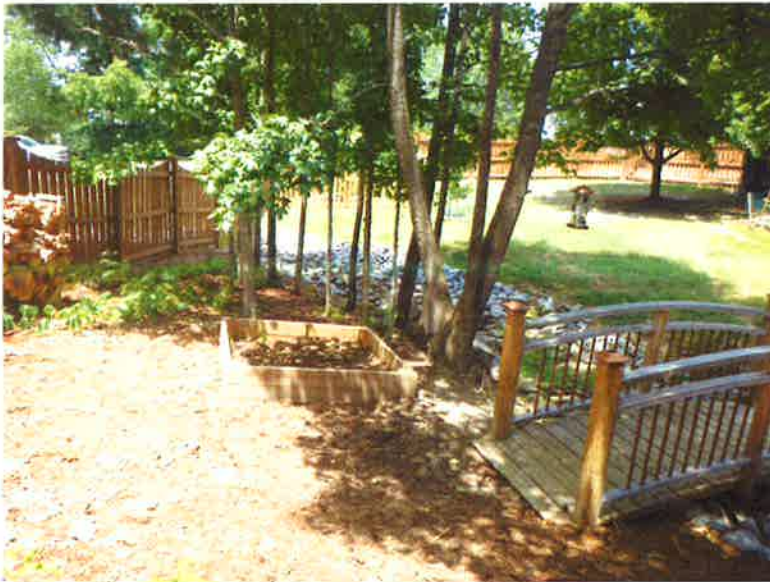
Emergency Spillway

A fence currently blocks flow in the emergency spillway in two places. **Routine Maintenance Item: Both fence locations should be modified to allow flow to pass unobstructed under the fence.**
